**SEISMIC RELIABILITY STUDY OF THE
SEATTLE WATER DEPARTMENT'S
WATER SUPPLY SYSTEM**

Seattle Water Department
Dexter Horton Building
710-2nd Avenue
Seattle, Washington 98104

Cygn Energy Services
2121 N. California Blvd.
Walnut Creek, California 94596

February 6, 1990

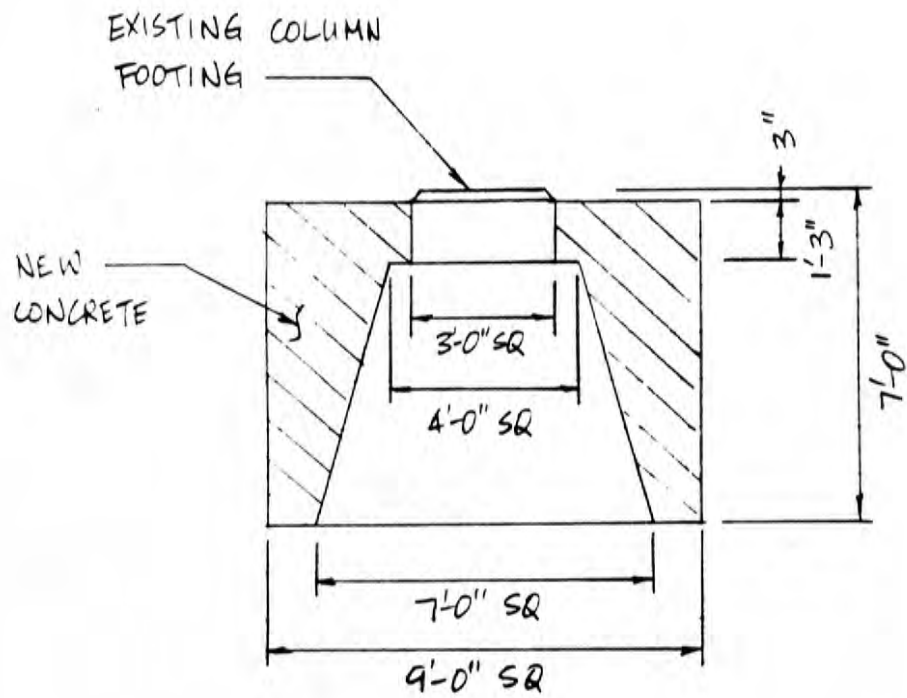
Figure 6.7-6

**Landsburg Elevated Water Storage Tank
Foundation Upgrade Alternative**

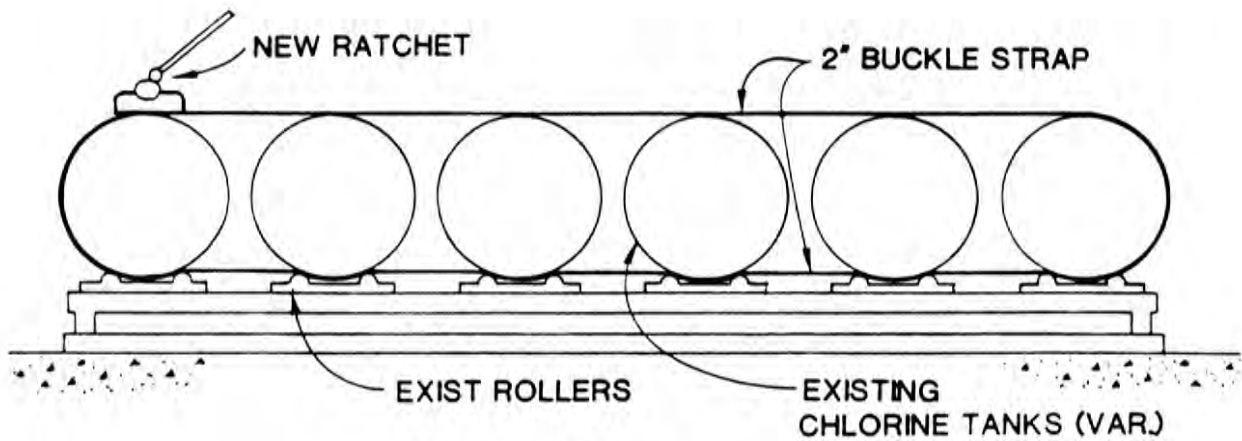
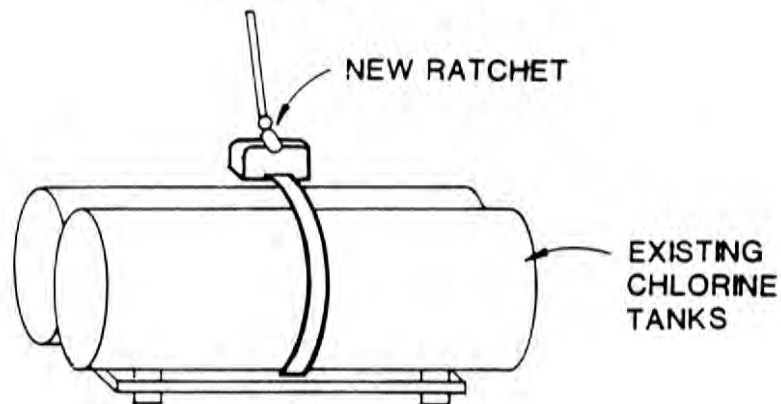
A common potential hazard was found in the chlorination facilities. The large chlorine tanks, supported on racks over scale pits, are not secured. The chlorine tanks could slide off their racks in an earthquake, rupturing the pressurized feeder lines and causing leakage of chlorine gas. Two alternative methods have been proposed for securing the tanks. The first is to wrap a strap around the tanks and tighten with a ratchet. The second is to construct removable reinforced bollards at each end of the tank racks, along with tube steel rail headers which are parallel to the tank rack on both sides. Either of these methods would prevent the tanks from sliding far enough to sever the feeder lines. The costs projected for securing the chlorine tanks in this report assume that both methods are used in combination.

Securing Chlorine Tanks - Strap and Ratchet Arrangement

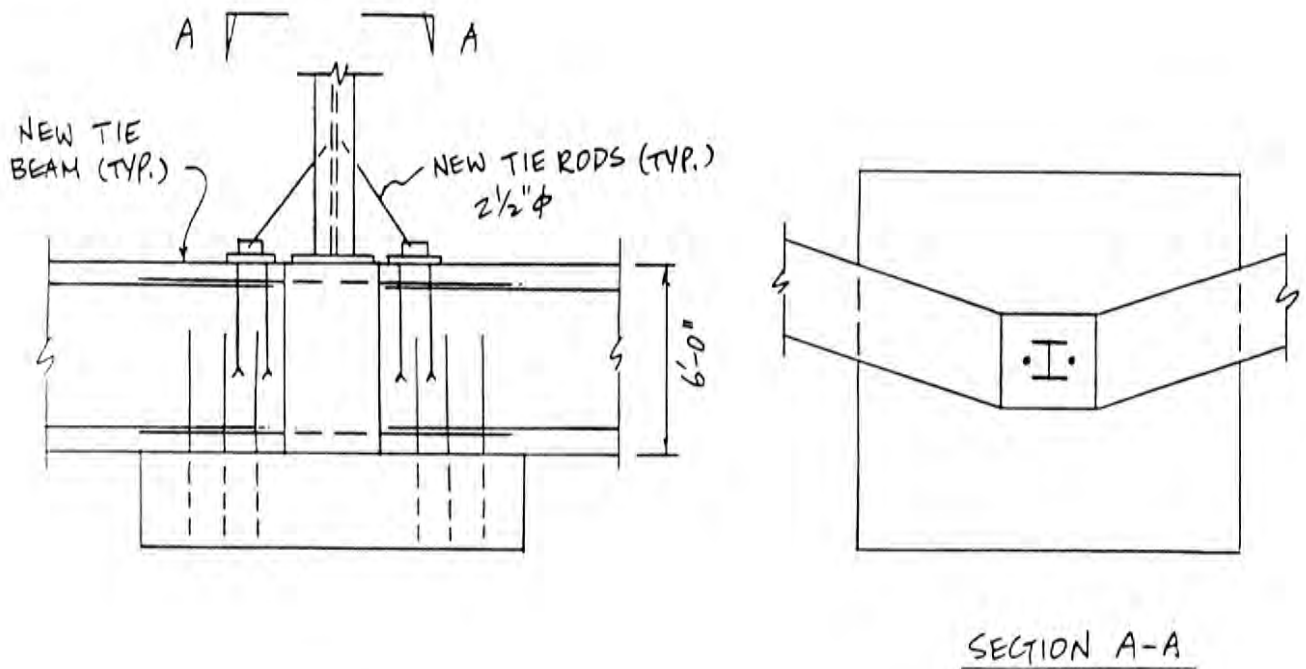
Figure 14.5-5

**Maple Leaf Elevated Water Storage Tank
Conceptual Foundation Upgrades**

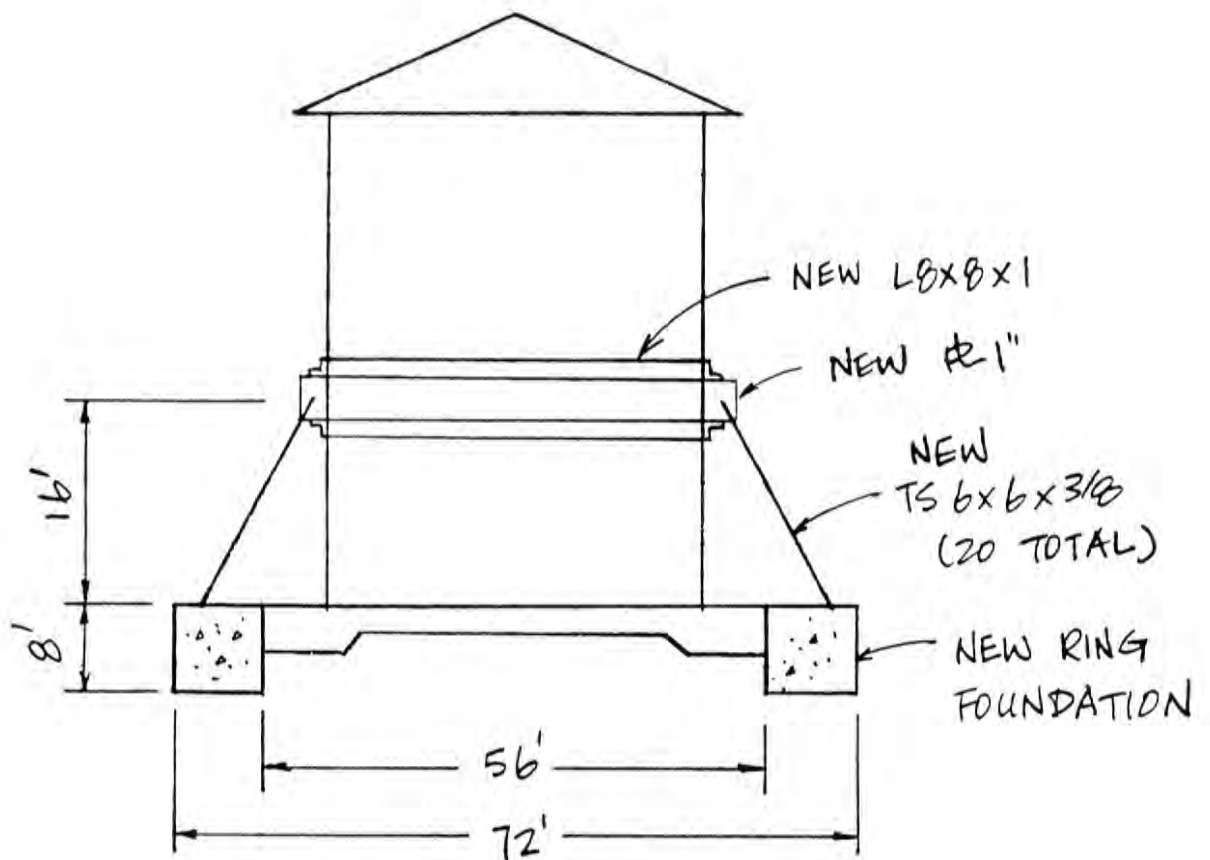
Figure 15.4.3

Charlestown Water Storage Standpipe
Conceptual Upgrade

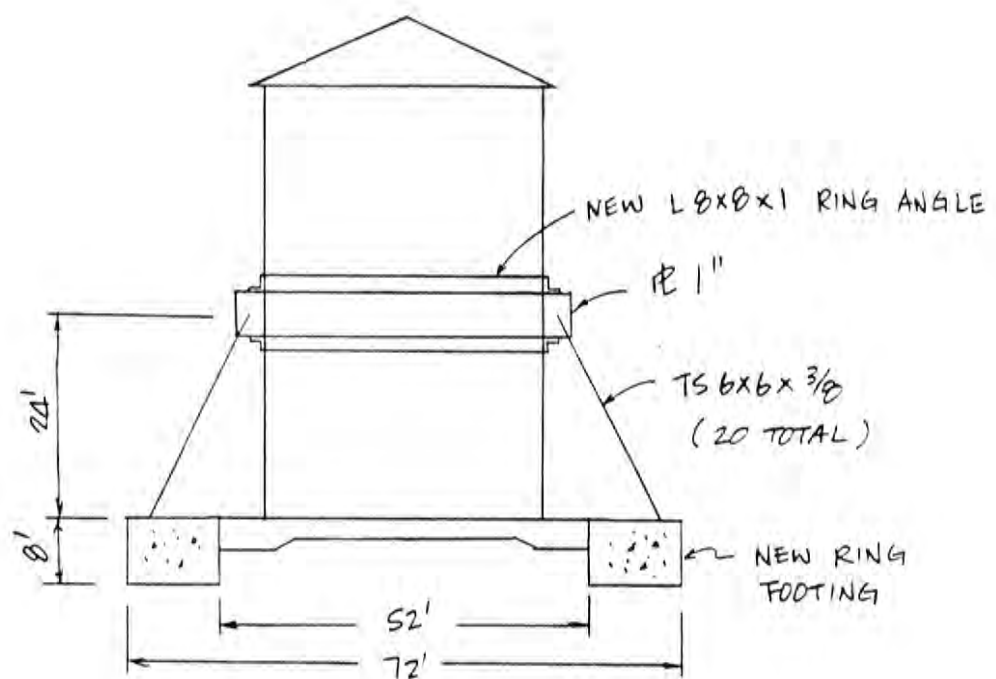
Figure 15.5-3

Foy Water Storage Standpipe
Conceptual Upgrade

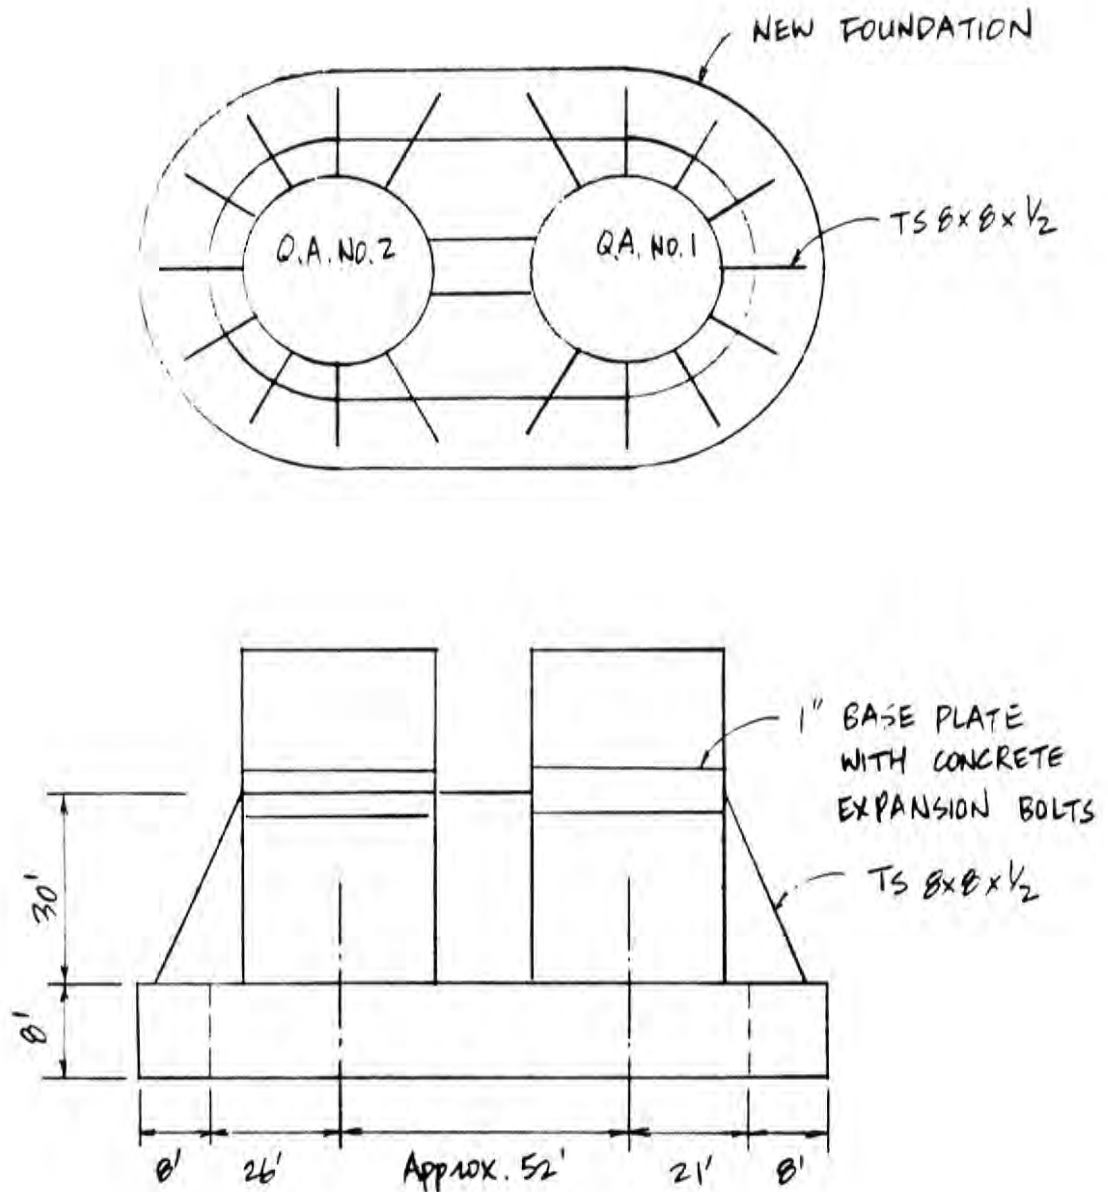
Figure 15.6-3

Queen Anne #1 and Queen Anne #2 Water Storage Standpipe
Conceptual Upgrade

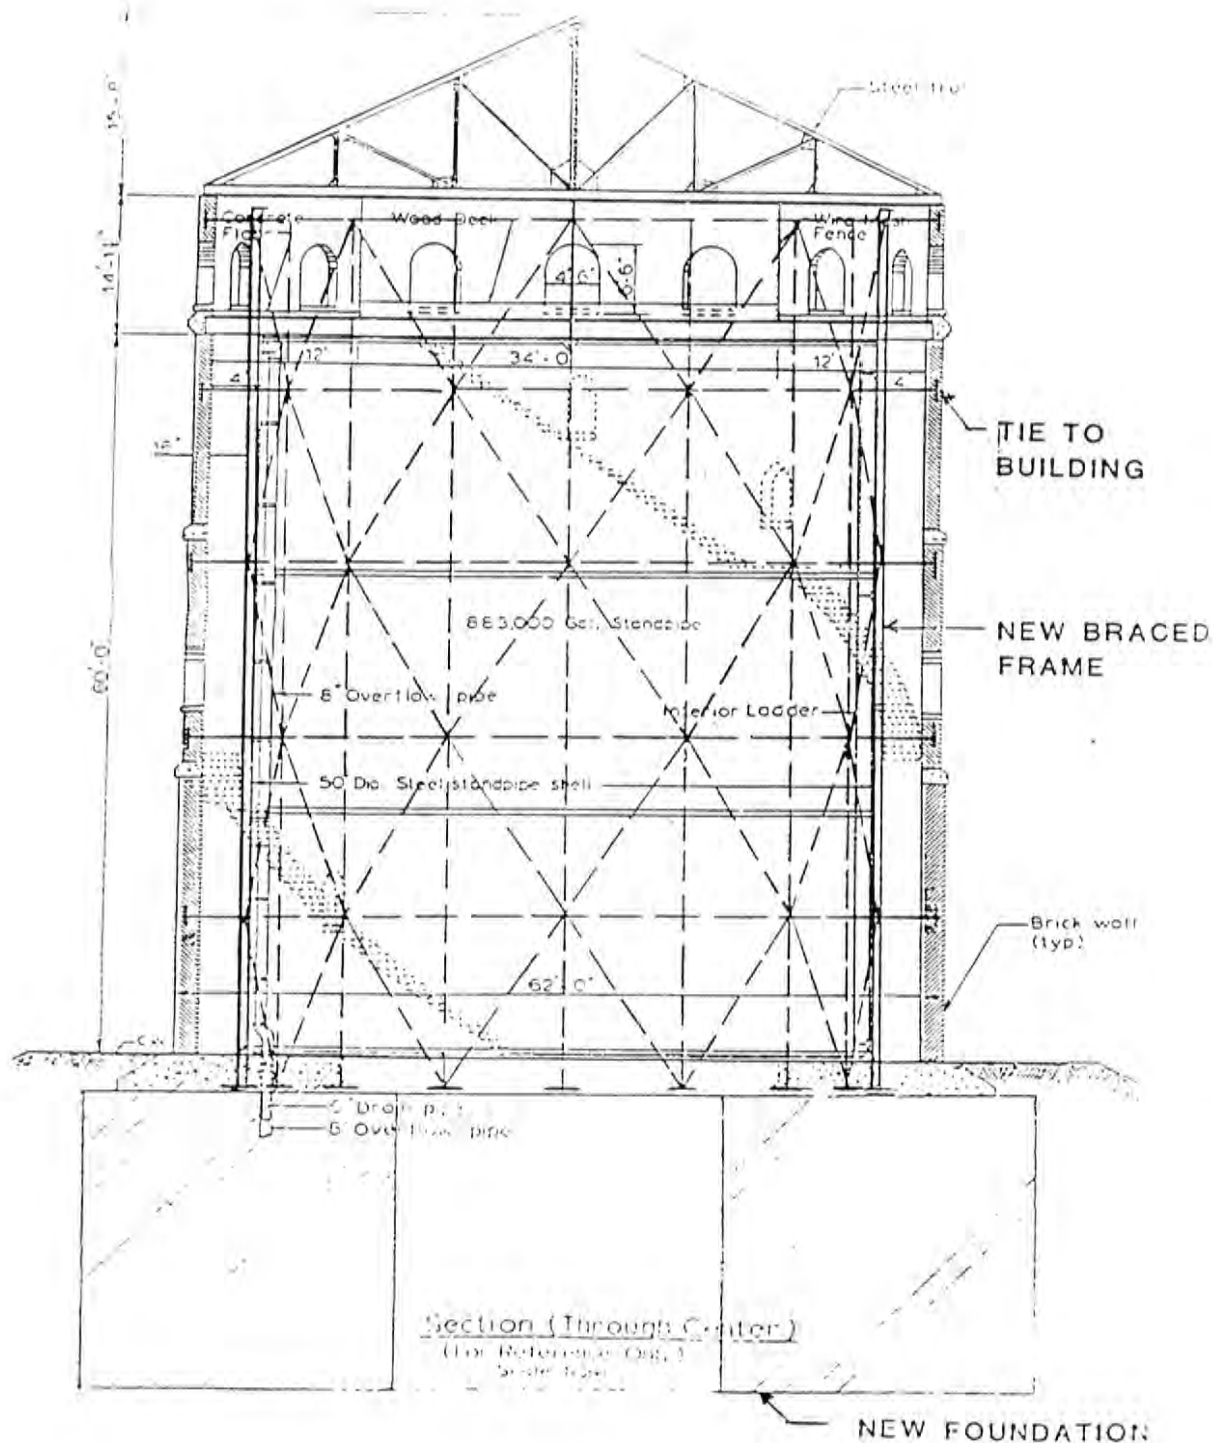
Figure 15.9-3

Volunteer Park Water Storage Standpipe Conceptual Upgrade
